# AMMO LASER Leak Detection System

## The #1 Safety Measure for Urea Plants with a Guaranteed Pay Back

### Question 11: What is reason number 5 to choose for a vacuum system ?

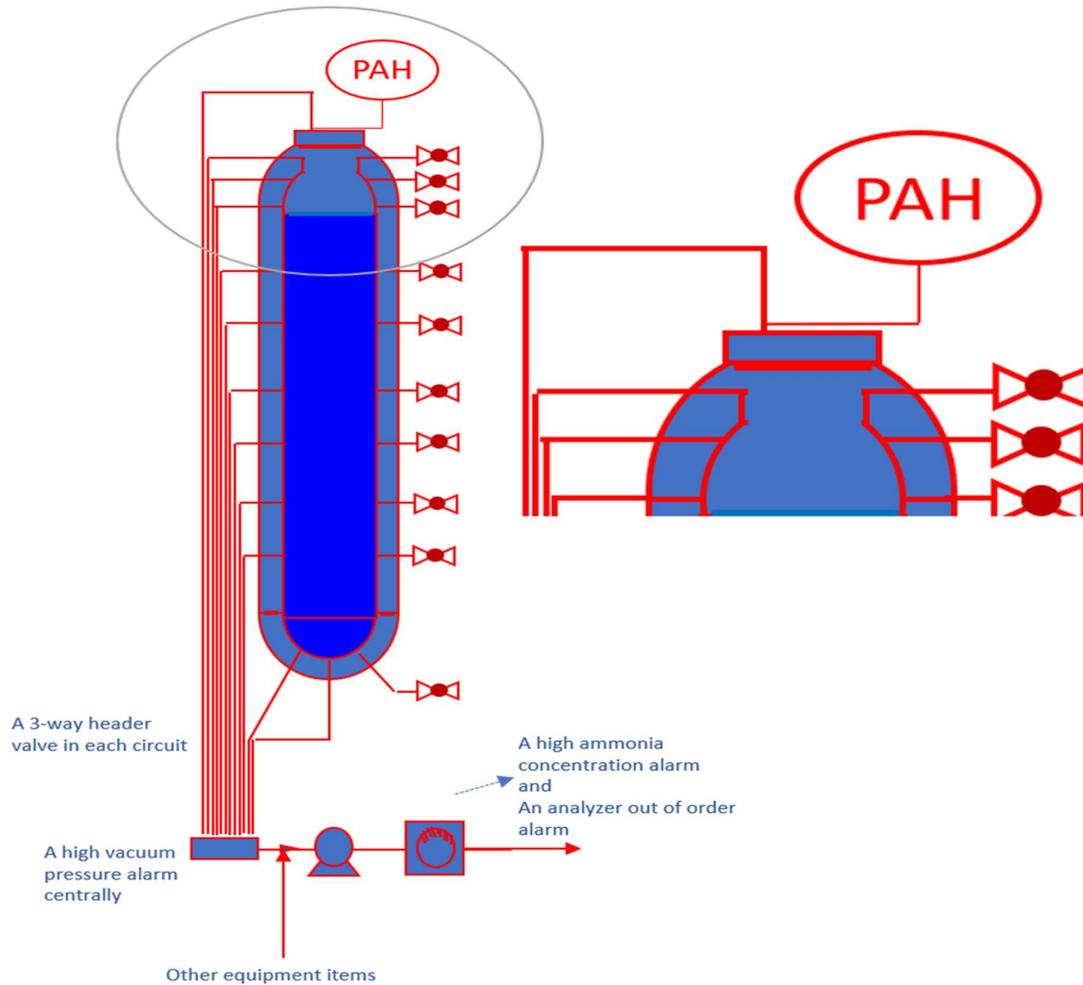
Due to the presence of just one leak detection hole one can however not be noticed of clogging. The risk of clogging however can be minimised by adding near to the leak detection hole a high pressure alarm as illustrated in the figure below. Other precautions are sufficient large diameter tubing, proper tracing and insulation and a reliable and accurate ammonia analyser.

Reason #5 is: A vacuum system also works when there is only one leak detection hole in a liner compartment.

There may be only one leak detection hole present in a liner compartment, a typical location where that might be the case is in man way covers of high pressure equipment.

When using a vacuum system that is not an issue; one pulls any leaking fluid via the leak detection hole towards the ammonia analyser by means of the vacuum pump.
